# Use of Geogrids in Wexford

*Donal McLoughlin BEng CEng*

*Wexford County Council*

## N25 Ballynabola to Raheenvarren Pavement Scheme

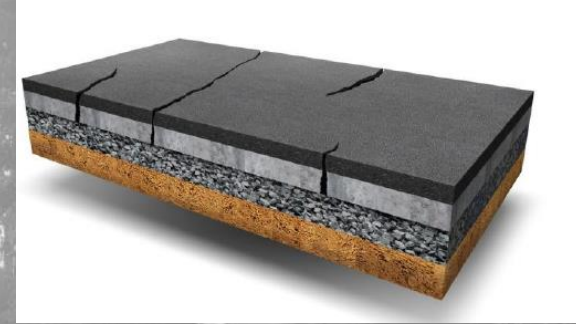
## Geosynthetics for Asphalt Reinforcement.

- Retardation of reflection cracking.
- Extends rehabilitation intervals.
- Extends the service life of road.
- Economic solution to add strength to a road.
- Reduces maintenance costs.

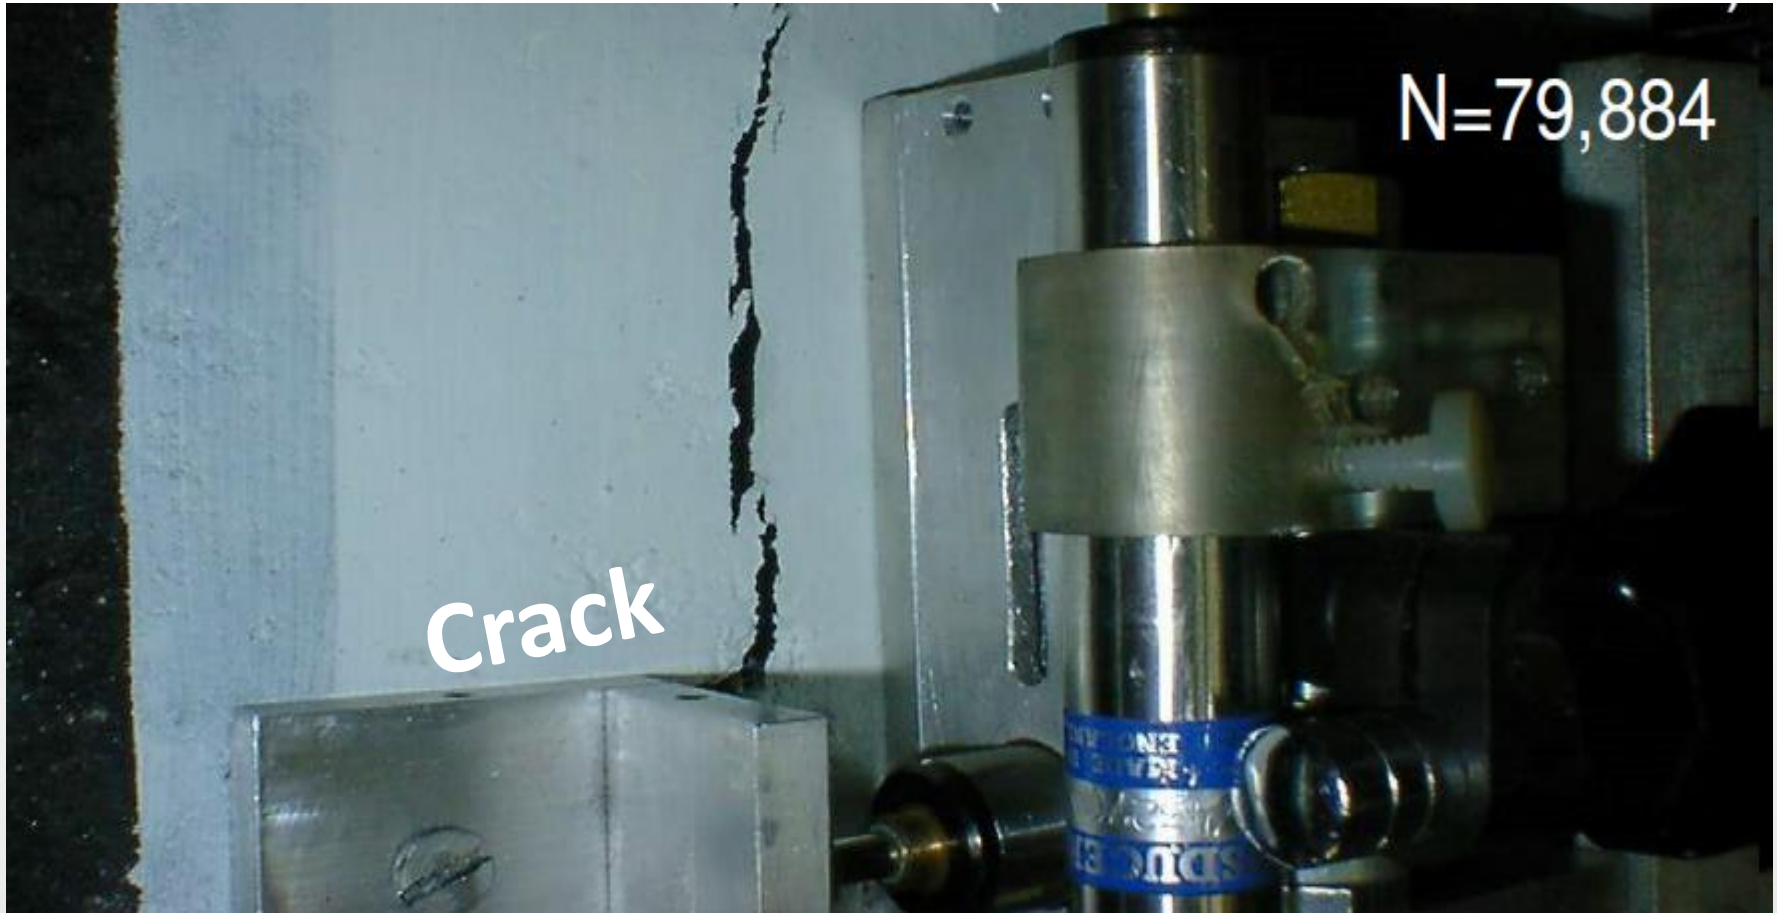
# Typical Pavement Crack (Without Reinforcement) Dynamic Fatigue Tests

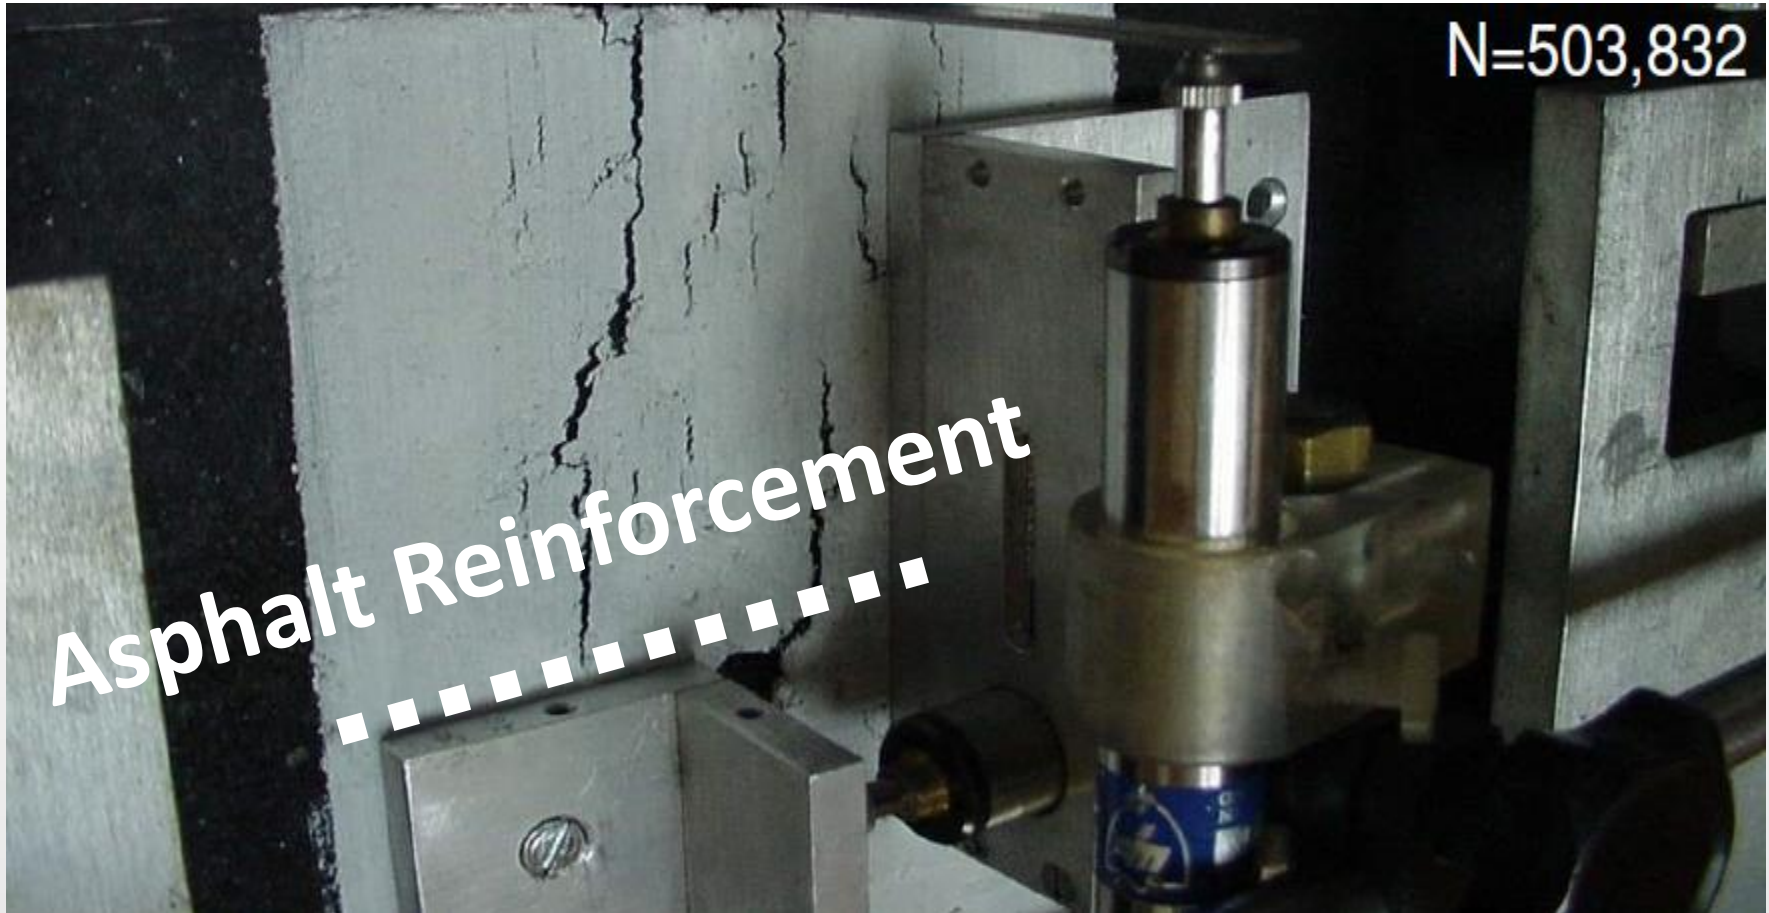
# Typical Pavement Crack (With Reinforcement) Dynamic Fatigue tests

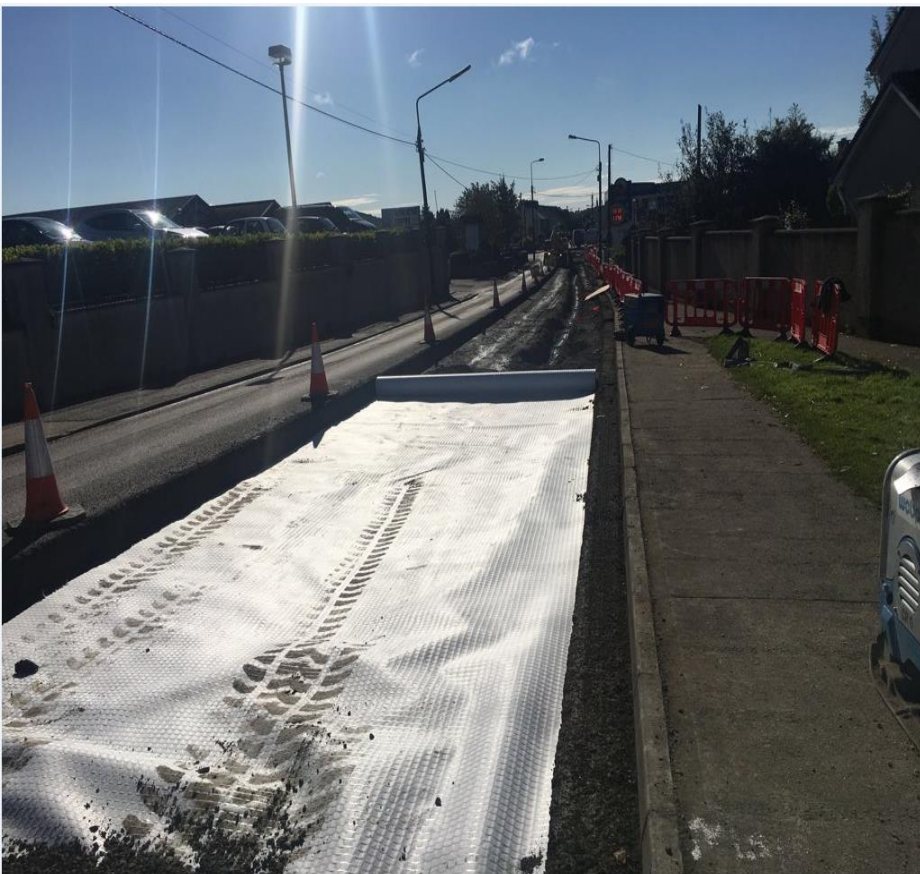
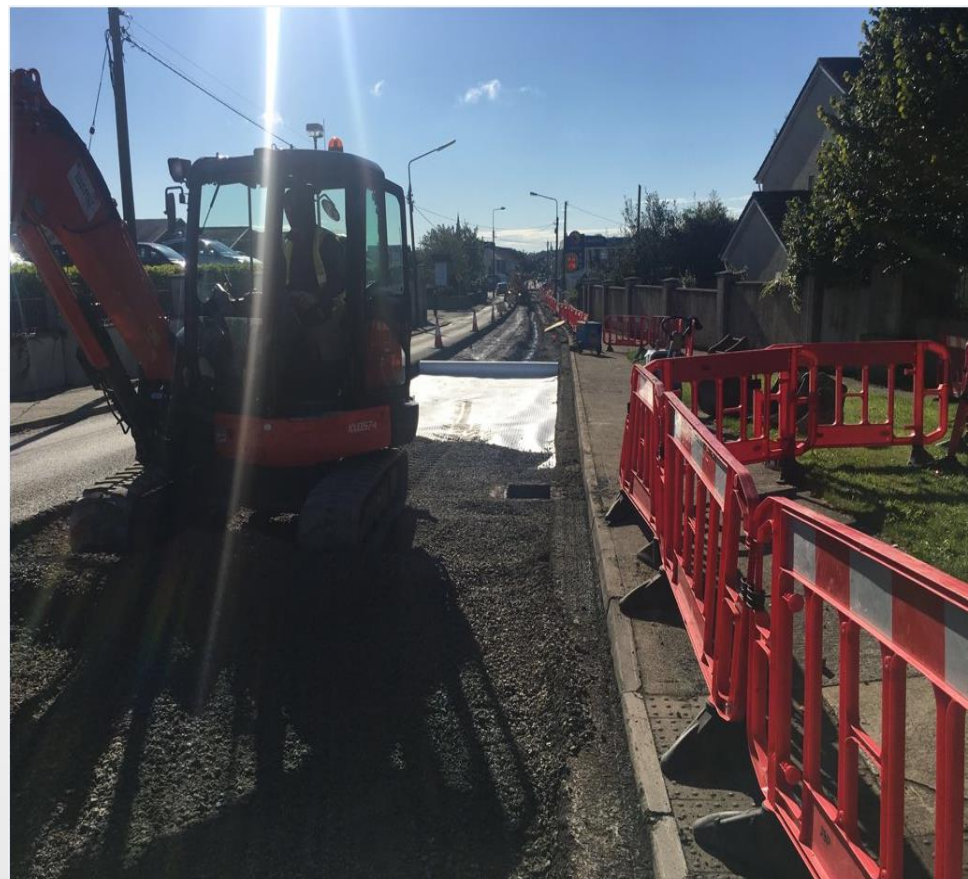
## Sub-Base Reinforcement Application

**R702 Rehabilitation/ Water Main Rehabilitation**

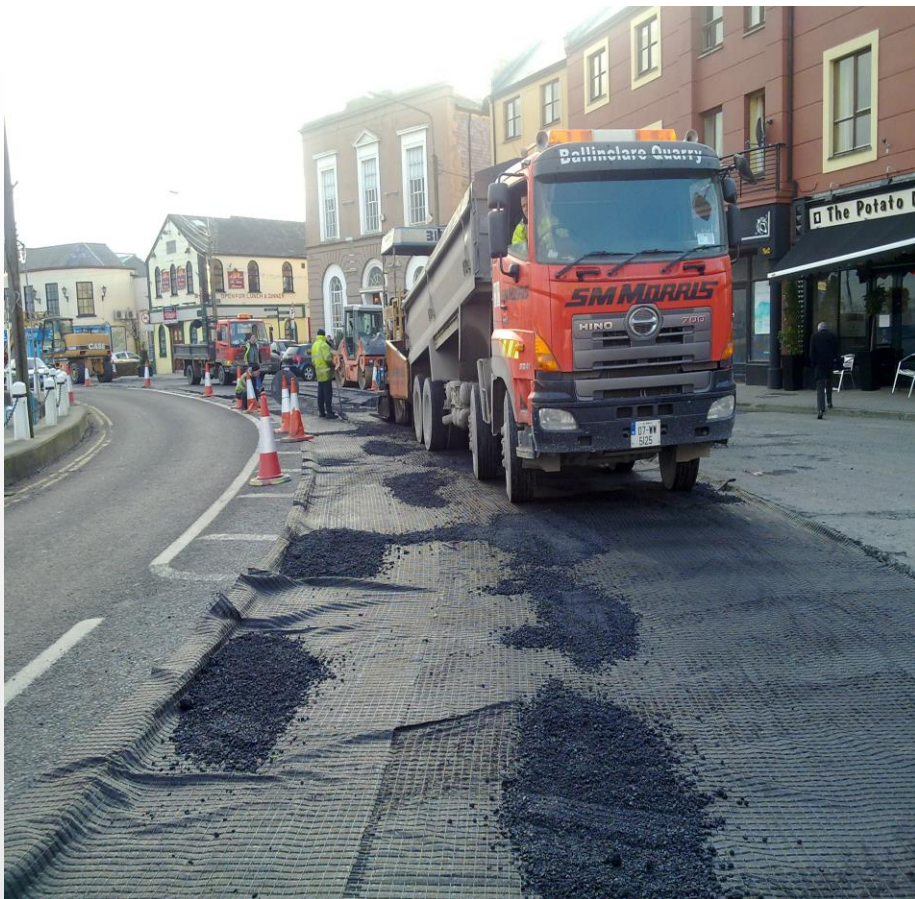
2009

## Asphalt Reinforcement Application

R730 Wexford Quay

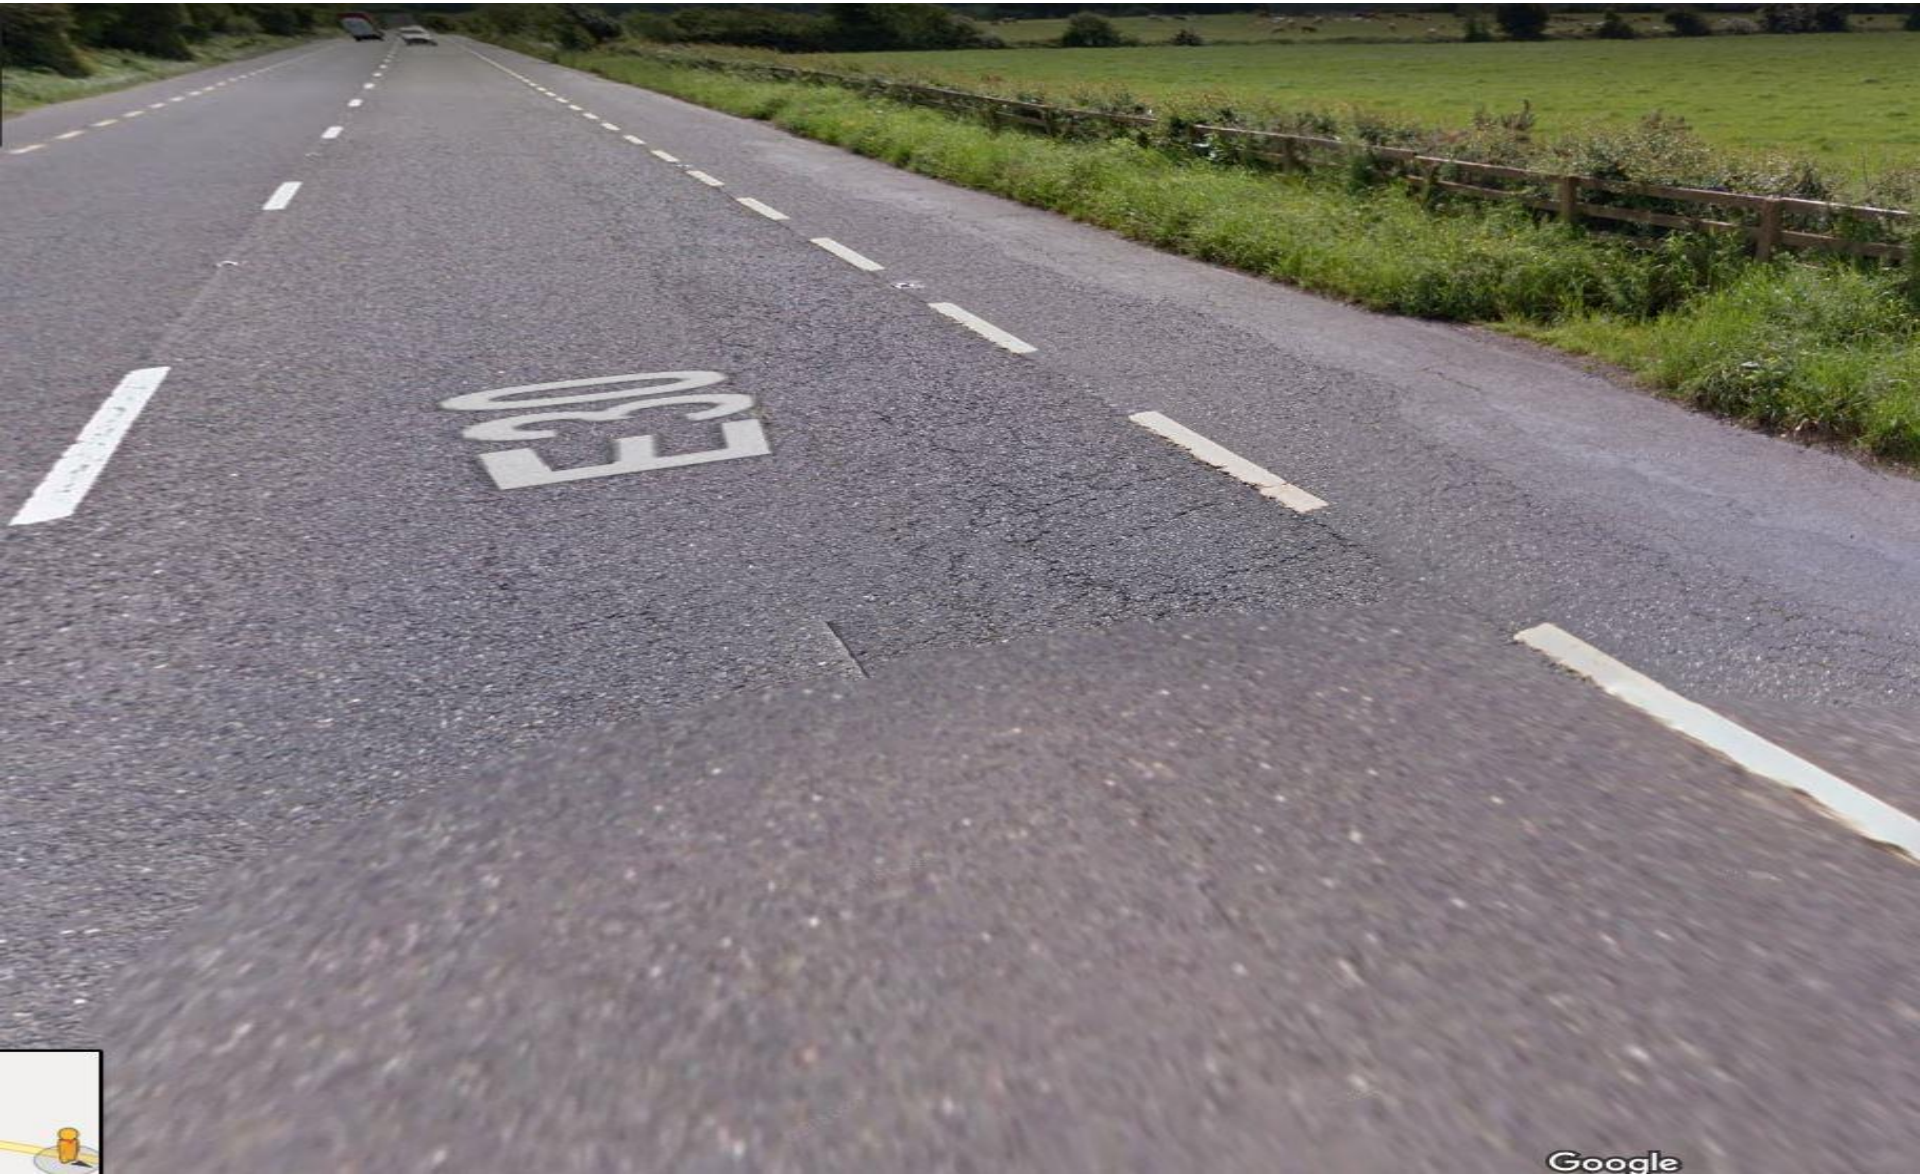
# Existing Pavement Condition : Rutting in wheel Track

- TII Asset Management Survey (2015 Red Flag).
  - Wheel track rutting
  - Cracking
  - Loss of skid resistance
- Identified the condition of the carriageway as Fair / Poor
- Local Authority survey work / interventions also backed up survey results.
- TII recommended that preliminary investigations be carried out, with a view to demonstrating the need for a proposed pavement scheme.

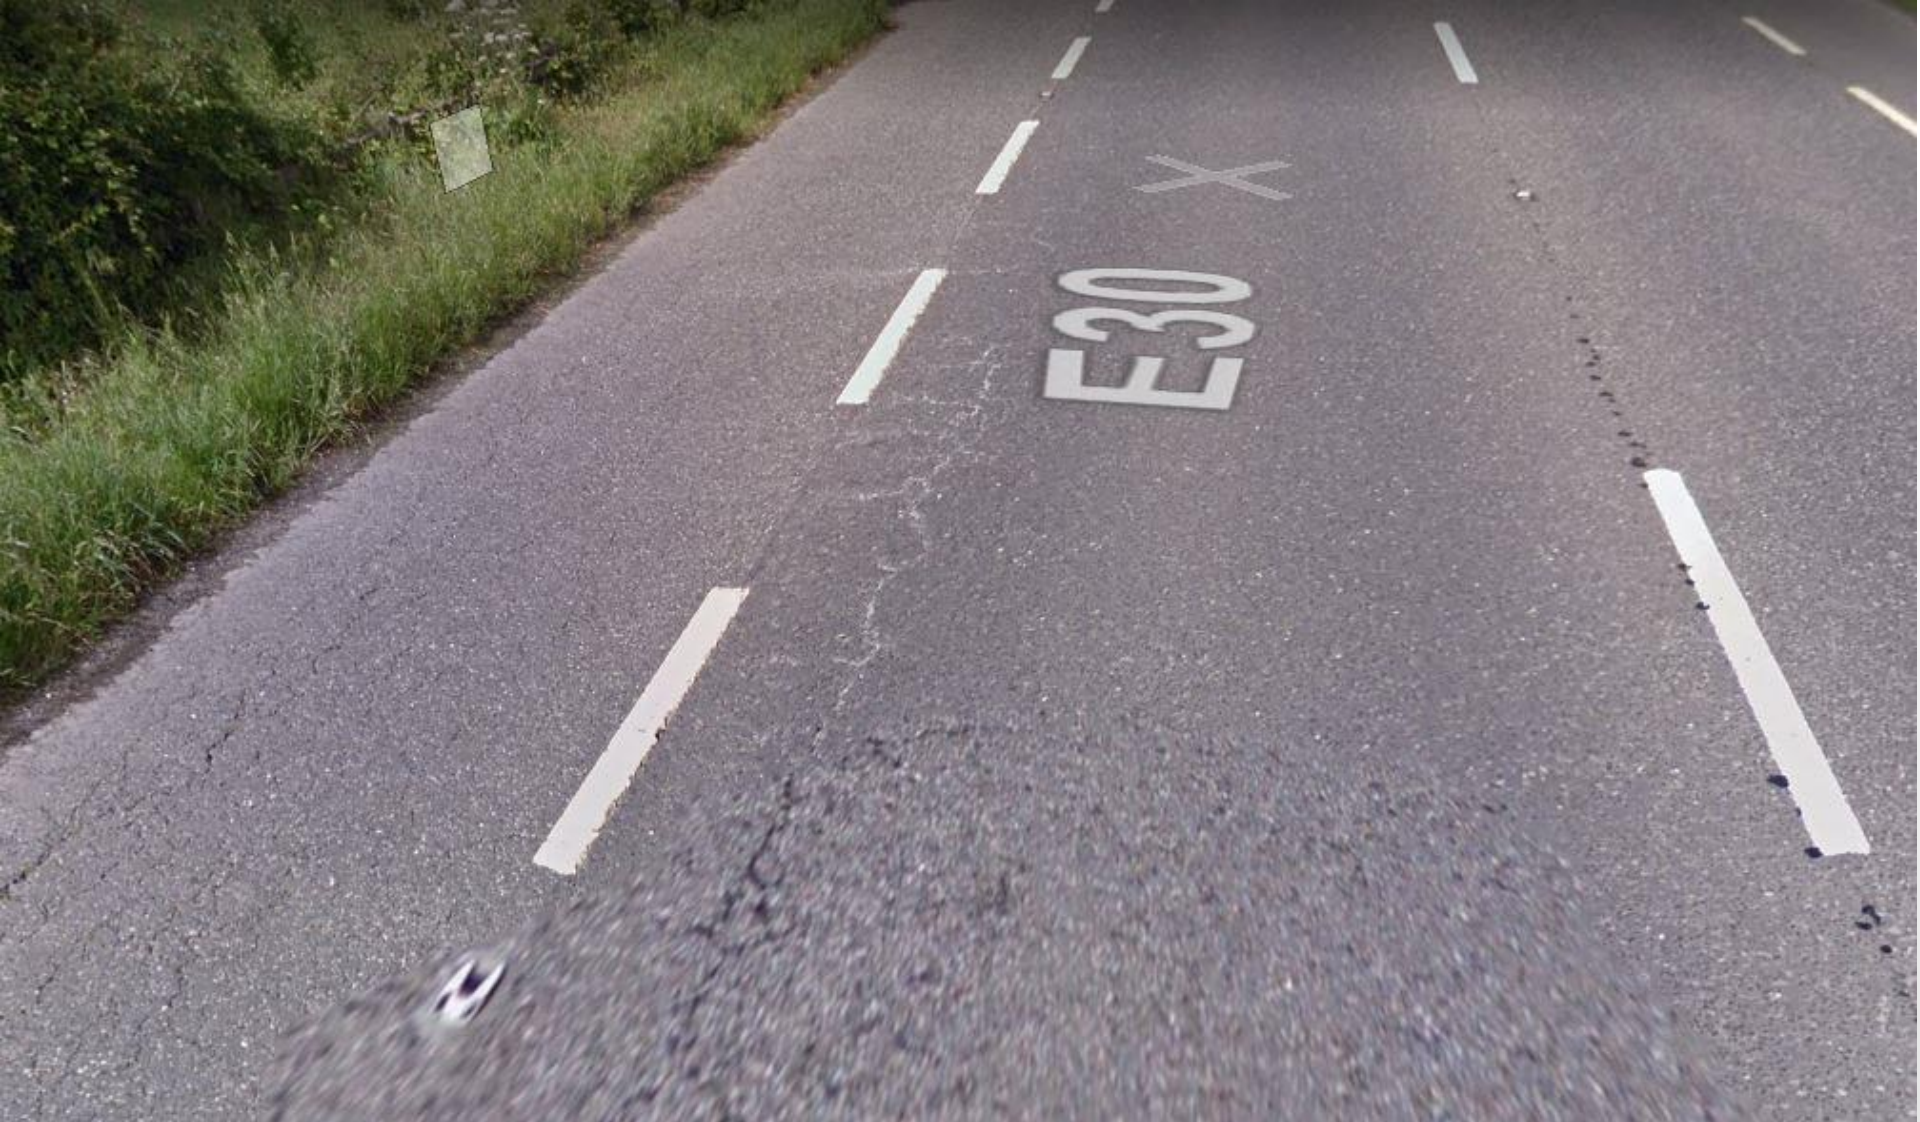
## Existing Pavement Condition : Cracking

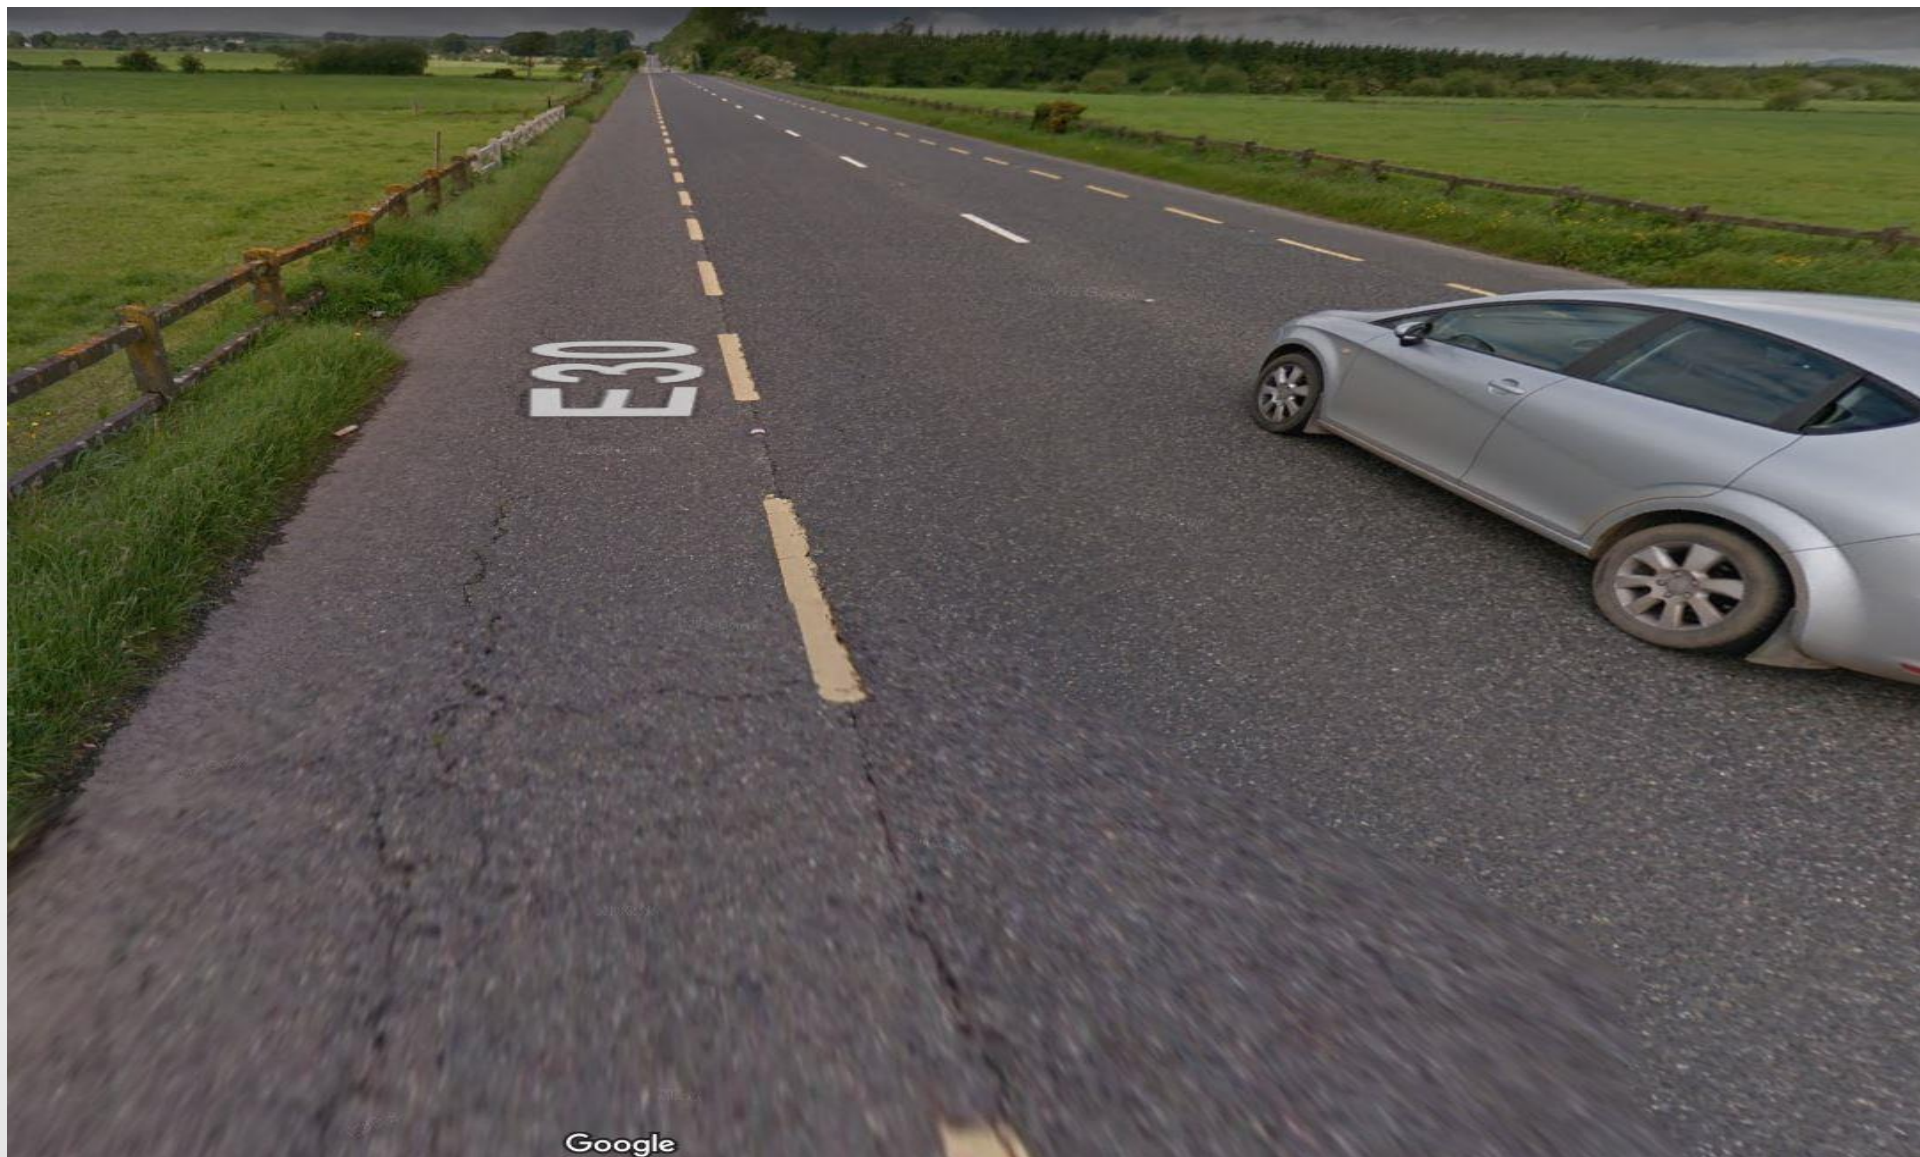
# Existing Hard Shoulder Failure

- Main Carriageway
  - Sectional repair of compromised pavement to a depth of 200mm
  - Overlay existing pavement with 55mm Binder Course & 45mm HRA
  - Install Asphalt Reinforcement to upper Layers to prevent future cracking & extend the life of the pavement
- Hard Shoulder
  - Cold mill Hard Shoulder to Sub-base level & install geo-composite reinforcement (Geogrid + Geotextile)

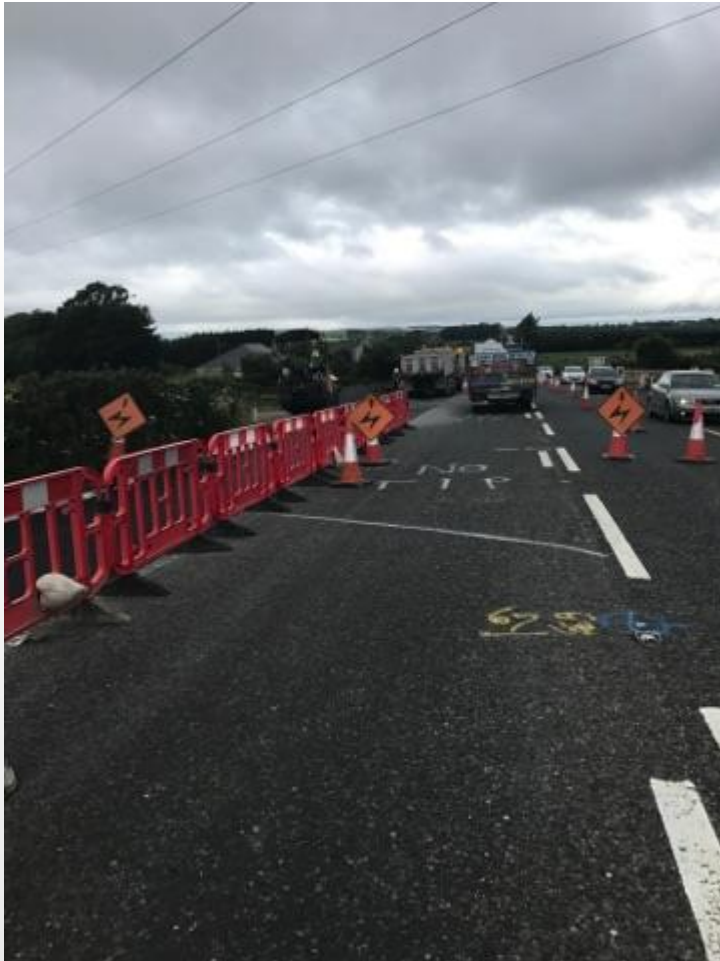
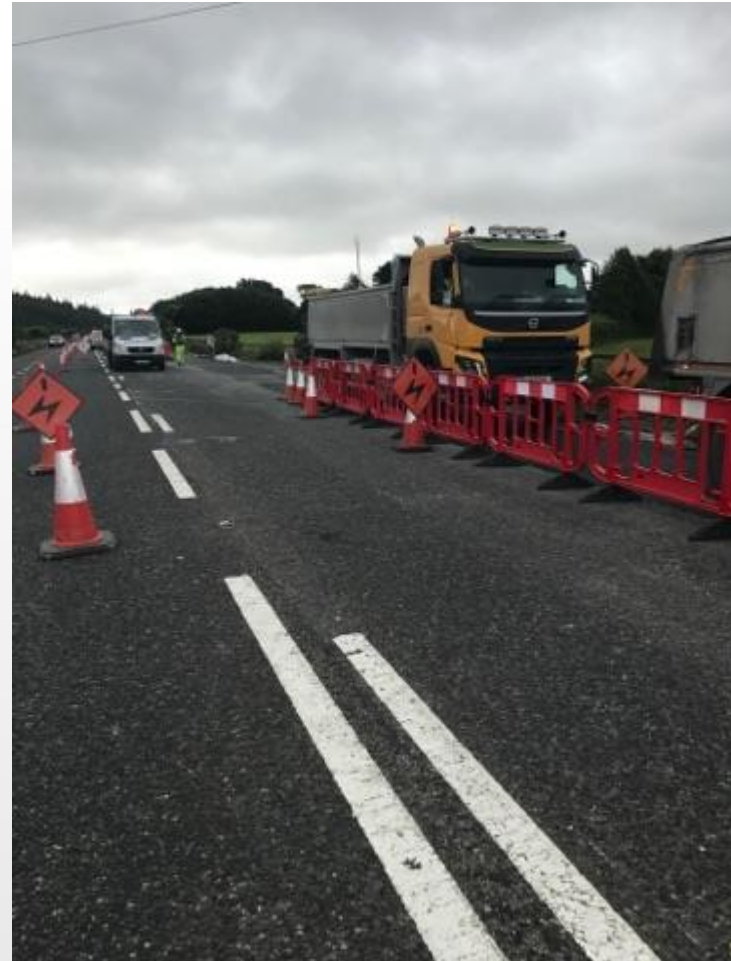
## Hard shoulder Rehabilitation.

1. Sectional repair of main carriageway
2. Excavate and repair WBHS. Including unbound reinforcement.
3. Pavement overlay Main Carriageway. Install Asphalt reinforcement on affected sections.

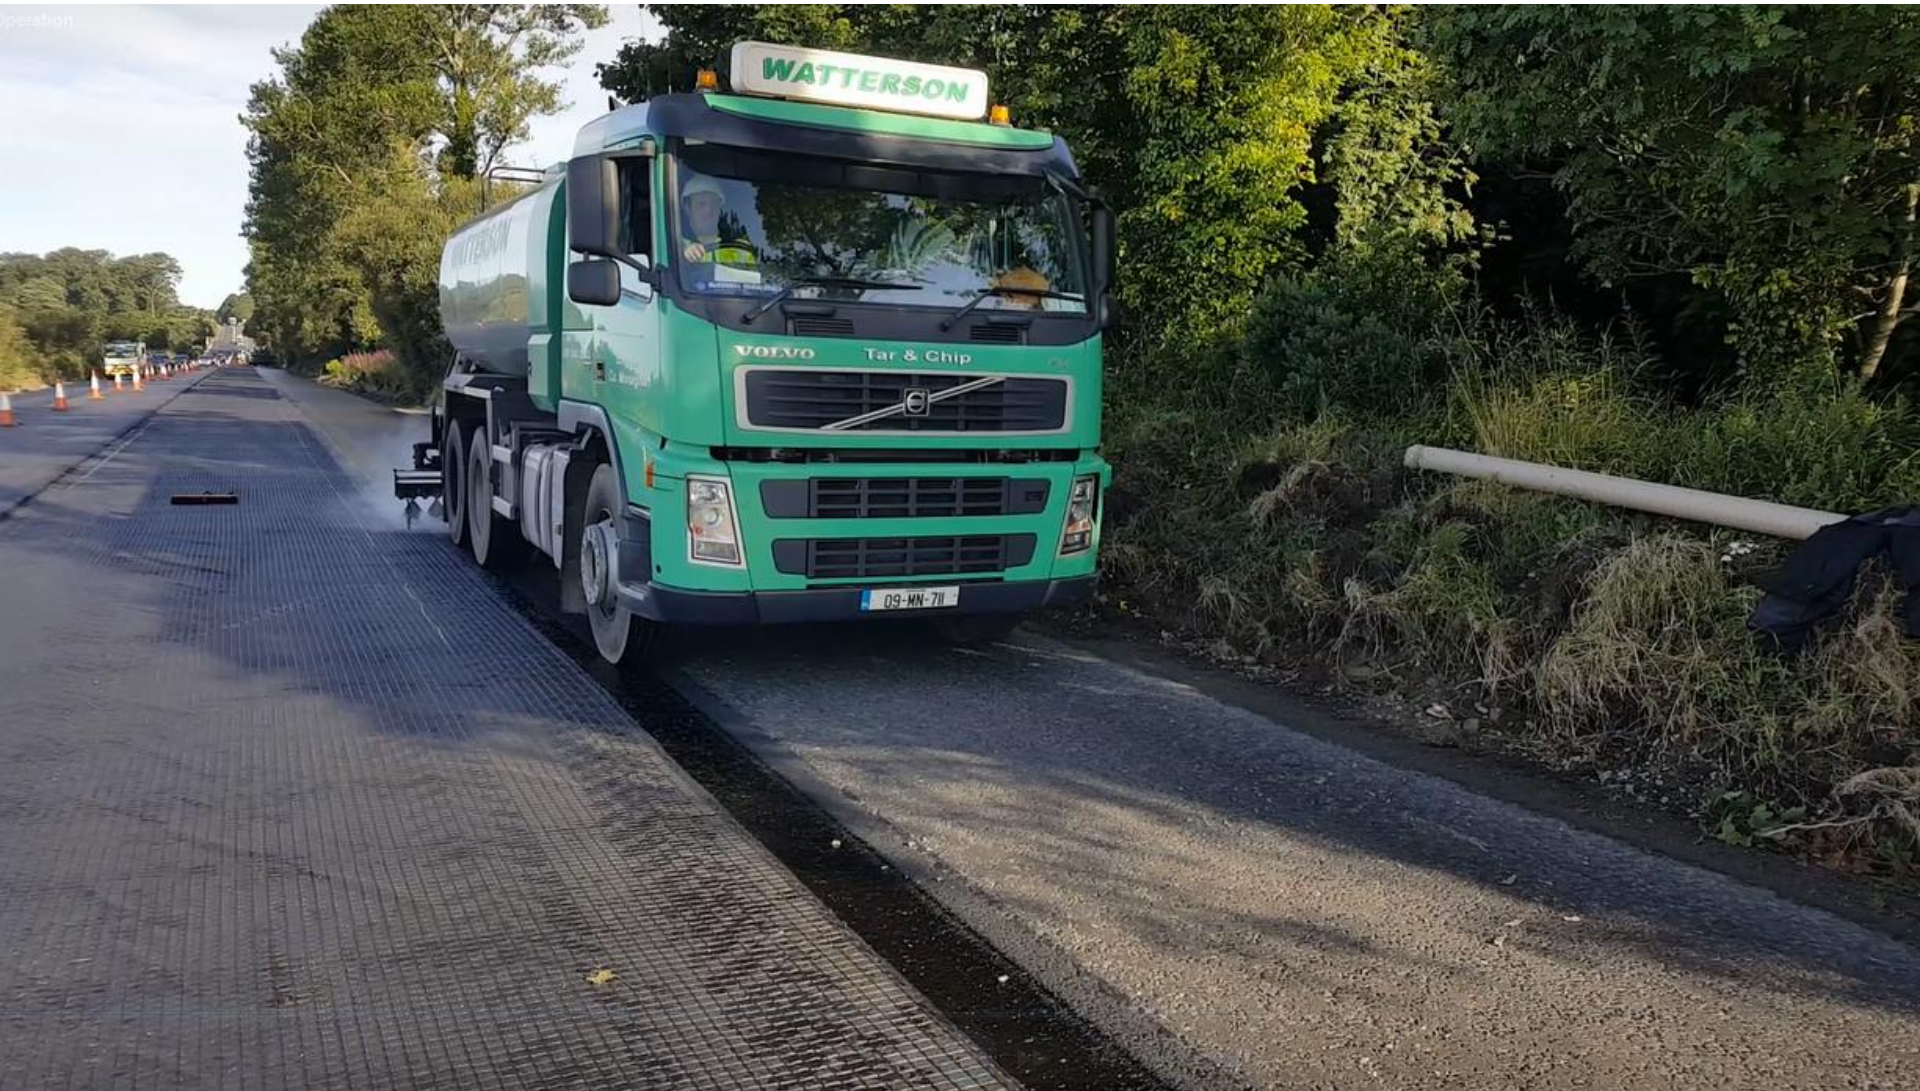
# Asphalt Reinforcement – Bond Coating

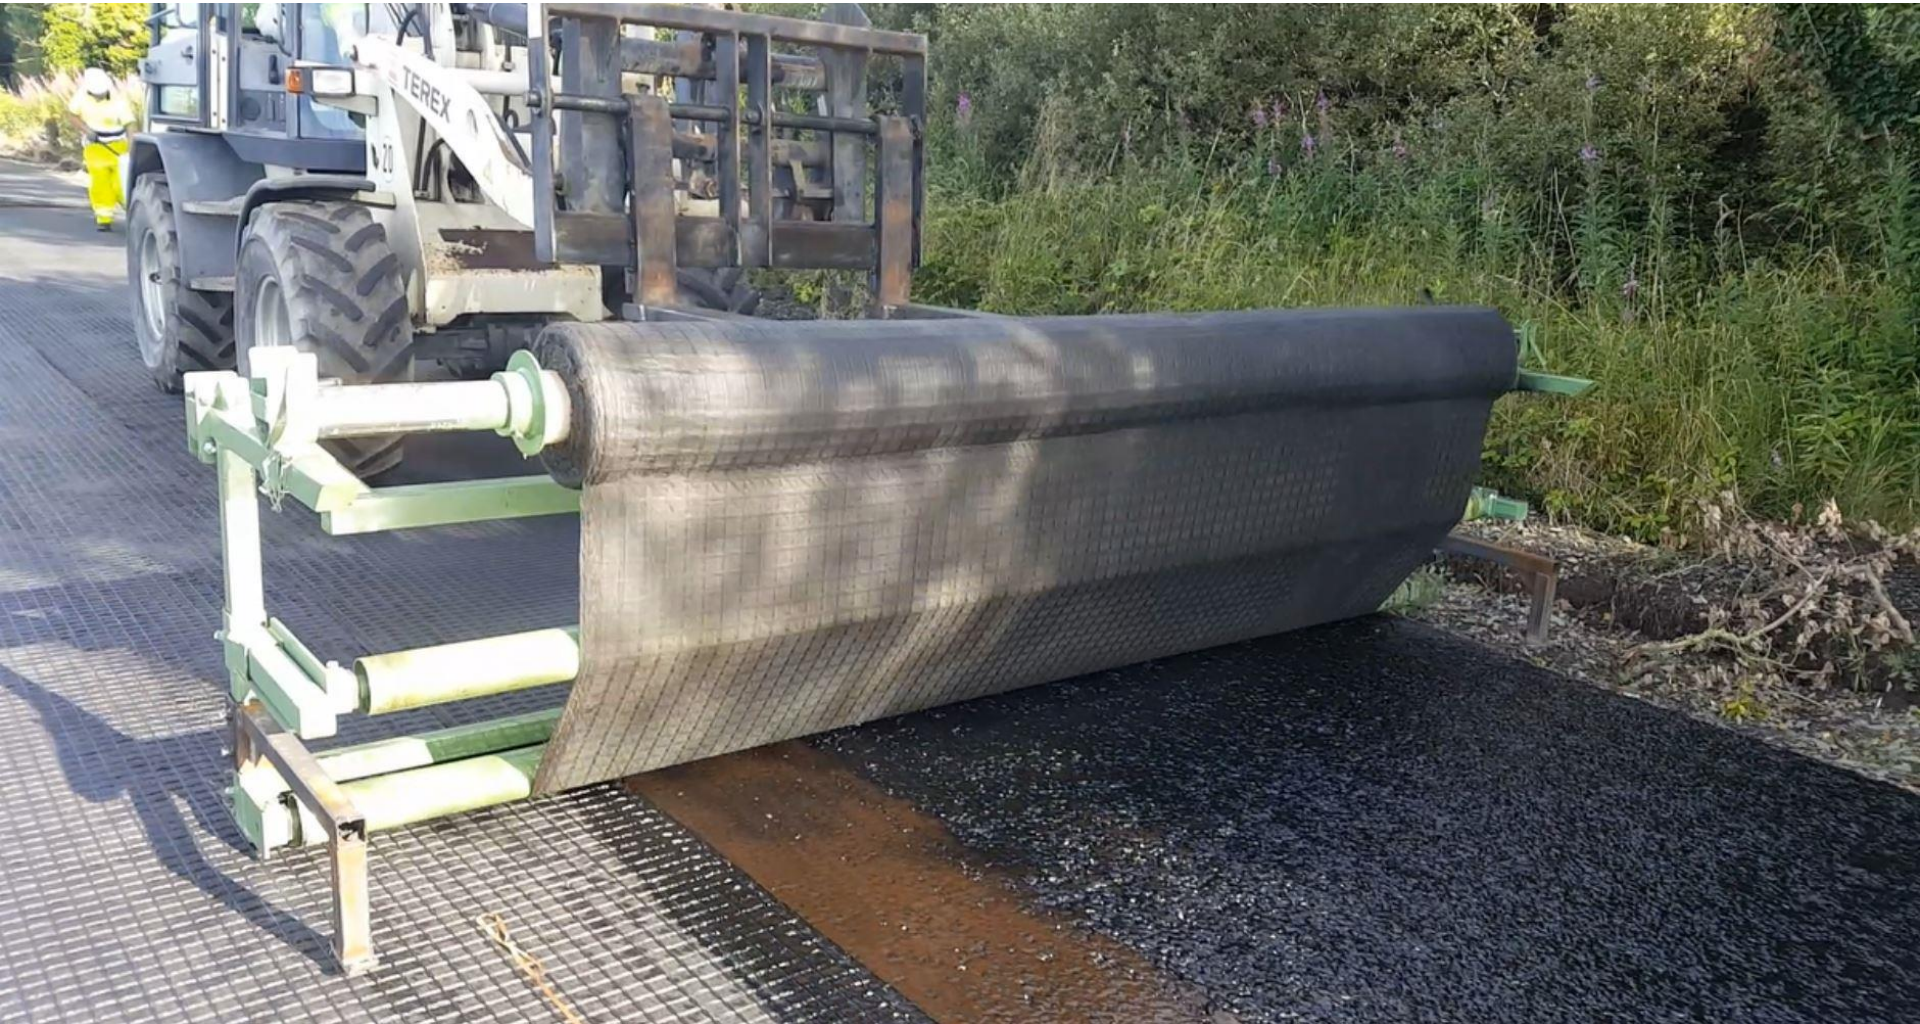
# Asphalt Reinforcement – Laying Process

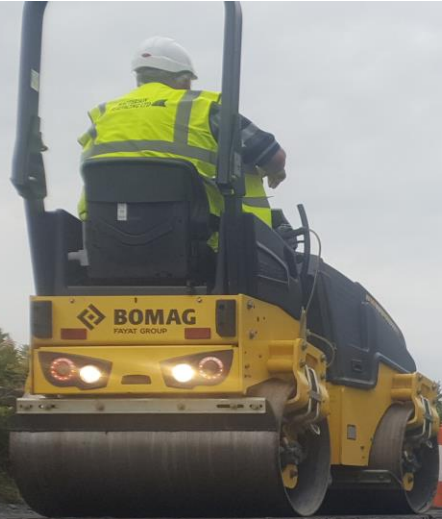
# Asphalt Reinforcement – Rolling

- Ultra light Weight nonwoven Backing
- Tensile Strength 50 Kn/m
- Bitumen content of Coating > 60%

Combination of bitumen coating grid & bond coat emulsion provided an extremely strong bond between the asphalt layers & geogrid

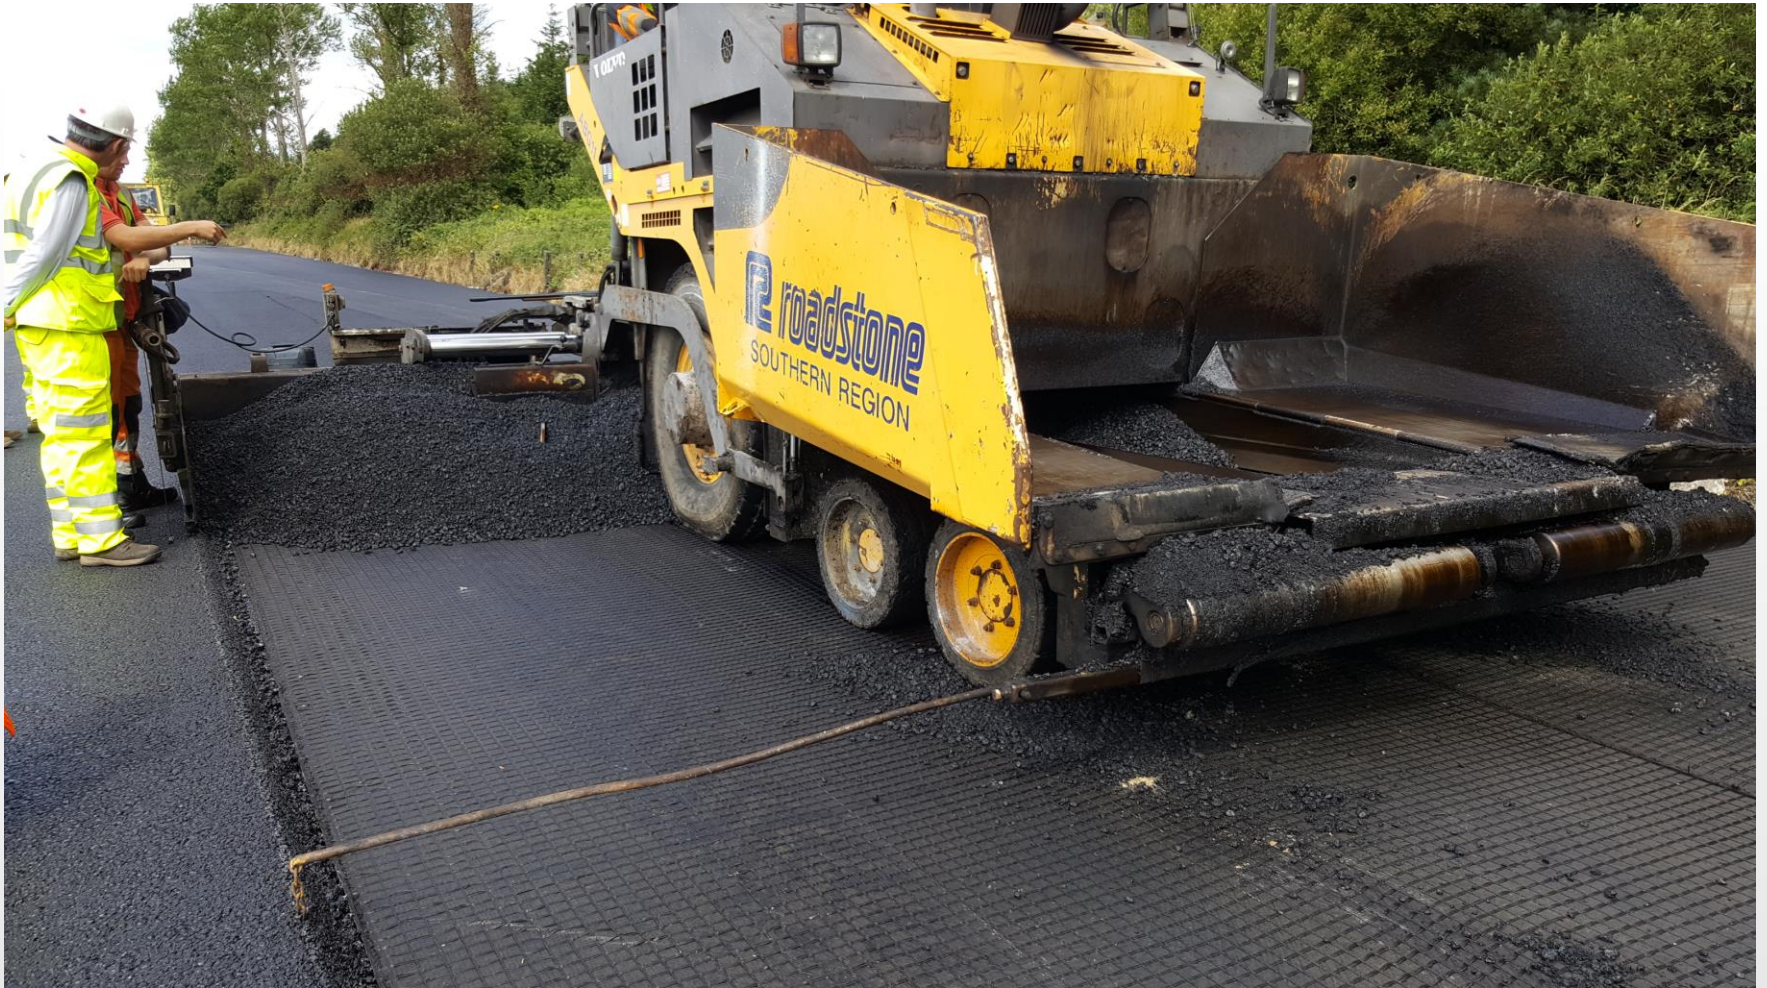
# Asphalt Reinforcement – Paving
