Assessing the Condition of the Irish Regional Road Network- 2018

Dr. Kieran Feighan PMS Pavement Management Services Ltd

John McCarthy Department of Transport, Tourism and Sport

Network Survey - Regional

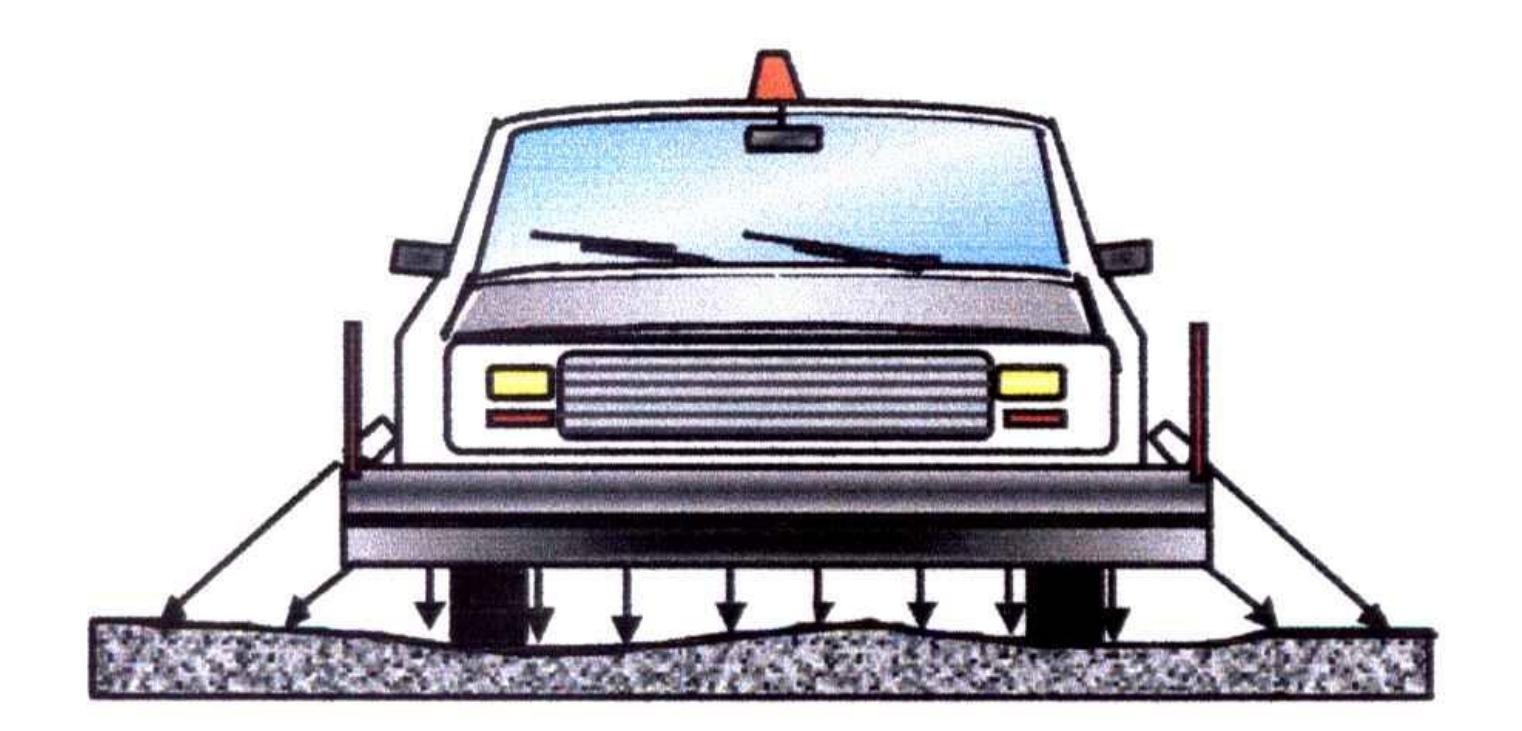
Cross Profile – Rut Depth

Rut Depth

- Indication of Structural Condition
- Caused by heavy traffic and/or inadequate pavement strength
- Rutting can occur in upper layers or in underlying subgrade
- Measured in both wheelpaths in mm

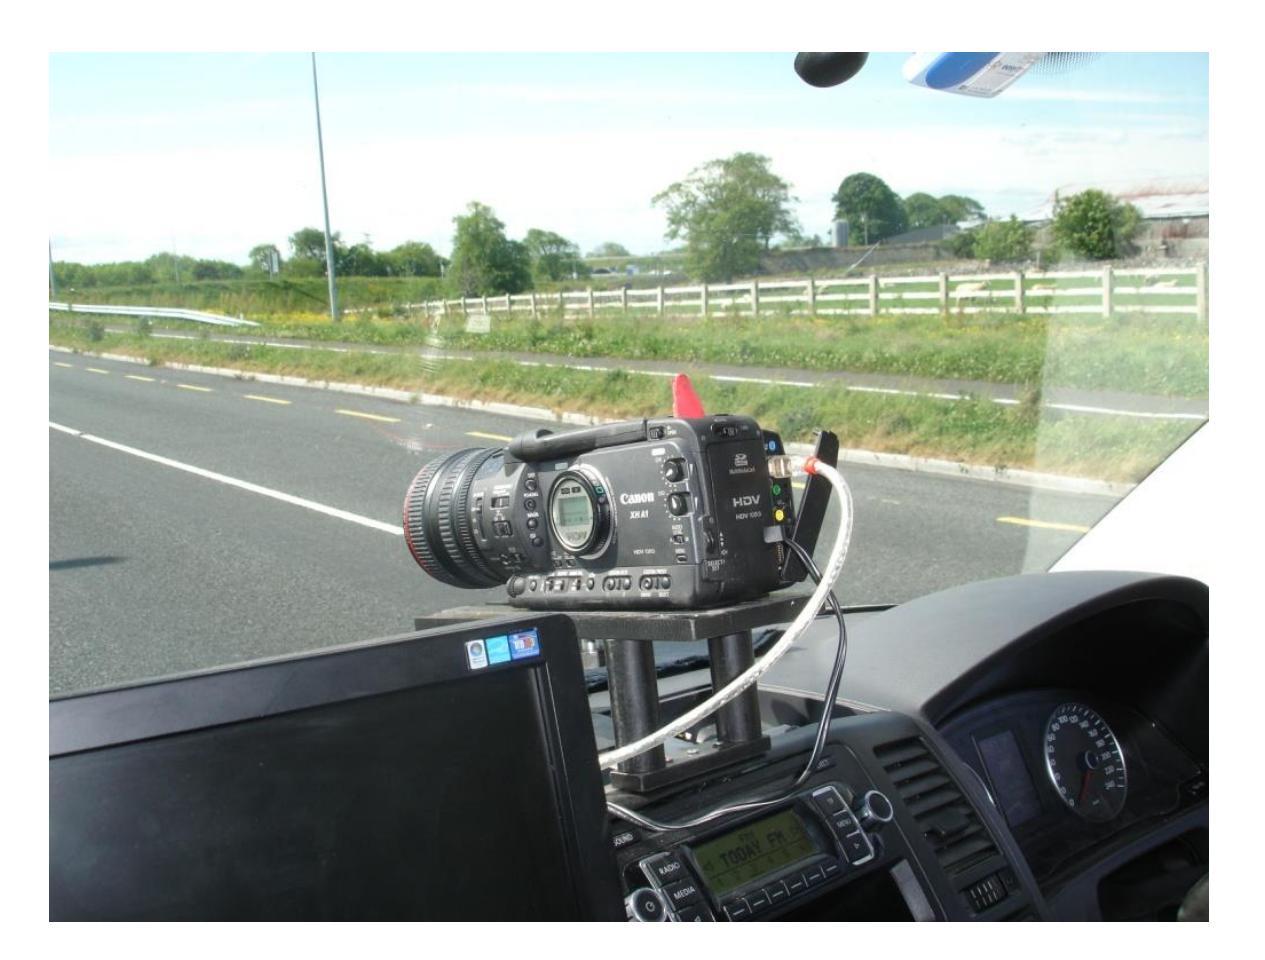
Forward View Digital Video

Pavement-oriented digital video used to capture the road surface condition.
